OLD RIVER DIVERSION, MISSISSIPPI RIVER

Report 4

OUTFLOW CHANNEL INVESTIGATIONS

Hydraulic Model Investigation

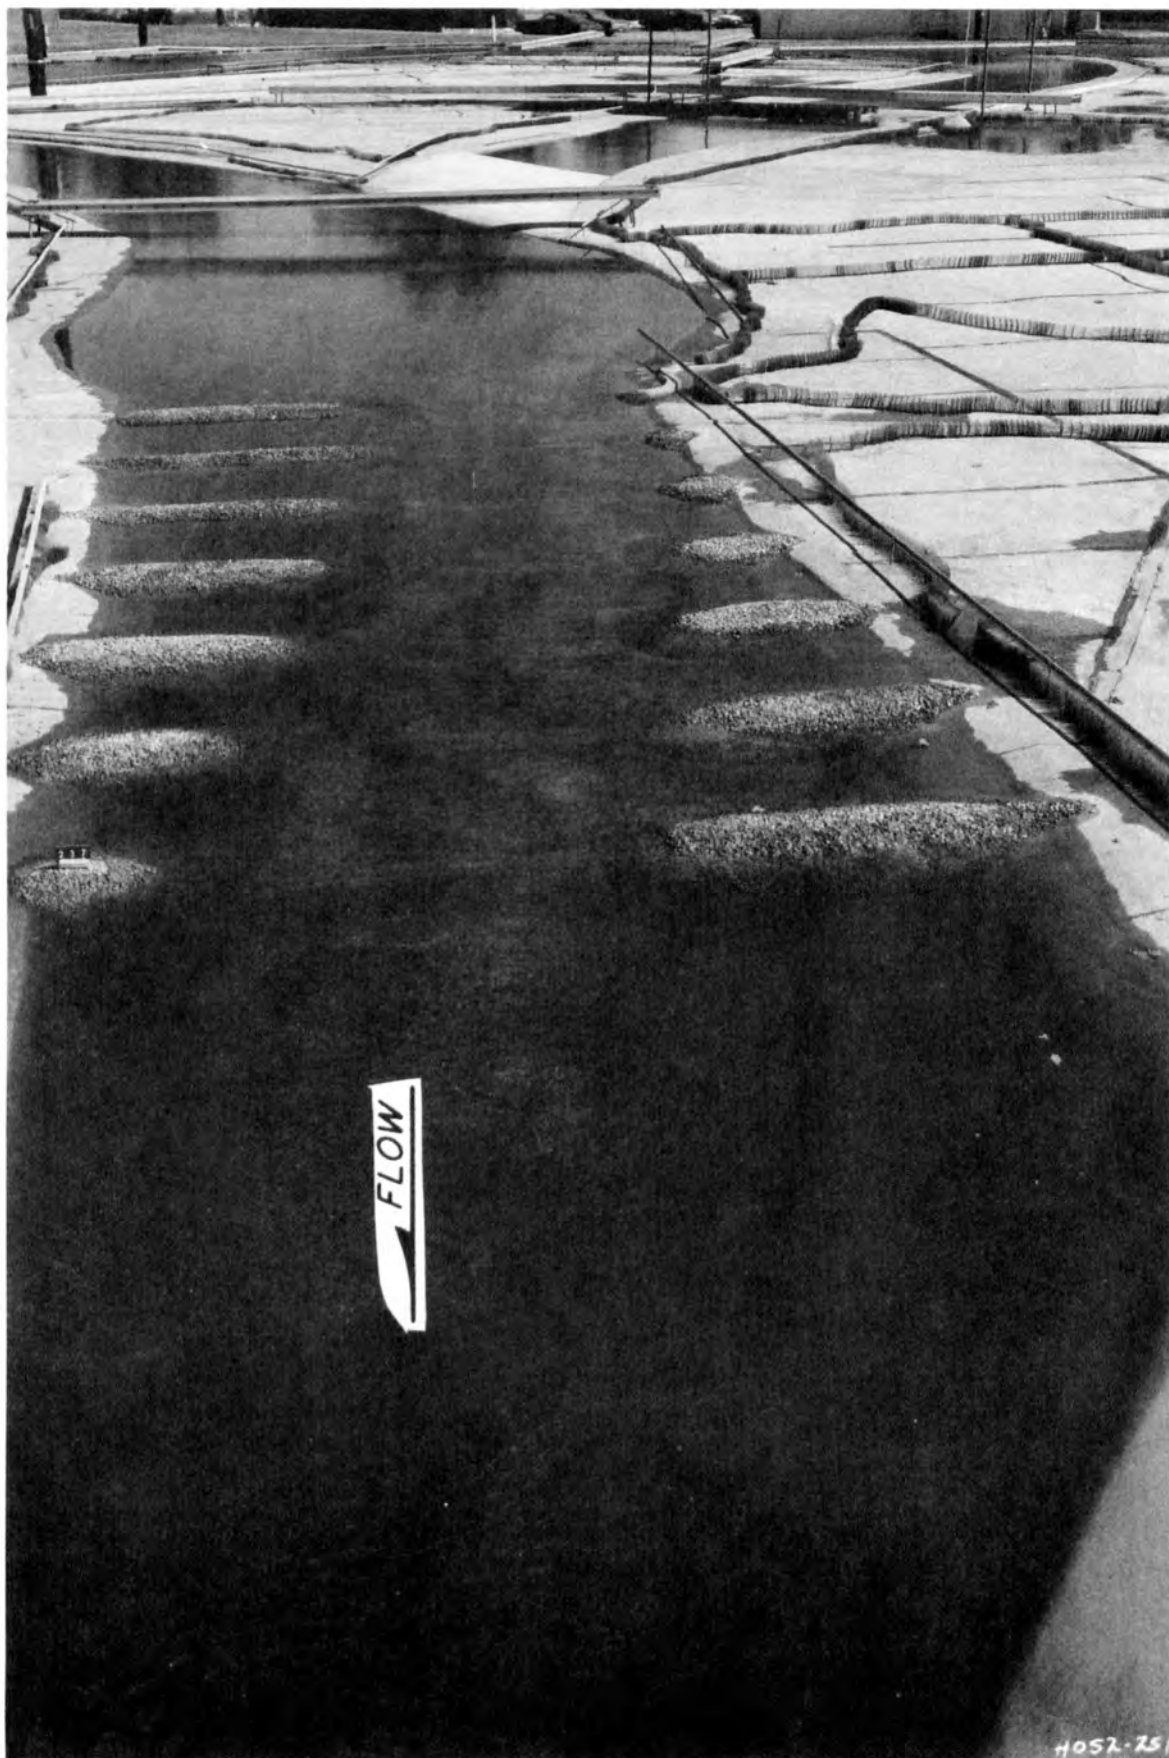
Figure 4. Tailwater control Plan 2, seven rock weirs

16. Description. Plan 2 consisted of seven weirs of the same type and elevation as Plan 1, except the weir section was 500 ft wide (Figure 4). The weir farthest upstream was at range 135+00 and tied to the railroad fill as in Plan 1. The six additional weirs were located 519, 1,029, 1,524, 1,998, 2,460, and 2,913 ft downstream of range 135+00; and their top elevation was the same as the overbank elevation at their location (Plate 8). These locations were developed to provide a spacing of 400 ft between the toes of the slopes of adjacent weirs. The weir sections were staggered from left to right across the outflow channel in order to follow the natural channel thalweg. Two additional Old River discharges, 315,000 and 380,000 cfs, were added to the three previous discharges for testing of this plan. Tailwater elevations were updated to correspond to a plot of desired headwater-tailwater elevations (Plate 10) furnished by the New Orleans District. Based on this plot, the following tailwater elevations were required for each flow:

17. Results. Table 2 shows the headwater elevations obtained for the five flows tested. The results indicate that the total head differential varied from 2.3 ft with the discharge of 100,000 cfs to 4.8 for the 380,000-cfs discharge. Approximately one-half to one-third of the total head loss occurred through the first weir. Velocities through the weir system (Plate 11) increased with the discharge and tended to become greater as the flow moved downstream. The greatest velocities were obtained with a flow of 315,000 cfs and occurred at the downstream weir. Velocities varied generally

from 7 to 9 fps with the 100,000-cfs discharge up to 10 to 14 fps with the 315,000-cfs discharge. Velocities did not increase with the 380,000-cfs discharge as there was flow around the lower four weirs onto the overbank area. These velocities are considered too high to allow navigation through the system.
